Manhole Inspection Summary

Manhole # S41A__018MH

Insp Date: **7/18/08 9:12 AM**

Location Address: **528 mcelderry st**

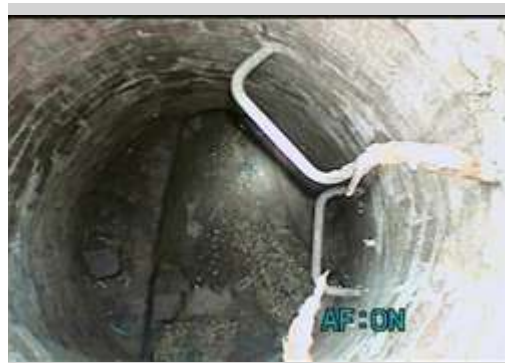
Top View

& steps

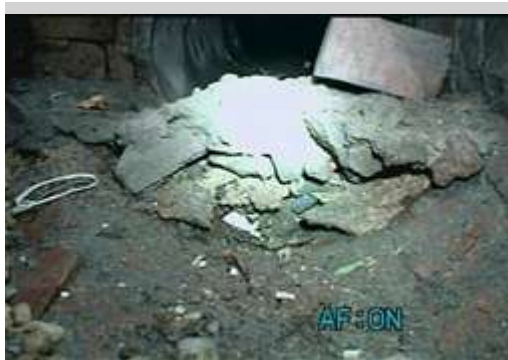
Defect 2

Condition: ☐ Sound ☐ Cracked ☐ Root Intrusion ☐ Deteriorated ☐ Leaks ☒ **Debris**

channel cond debris

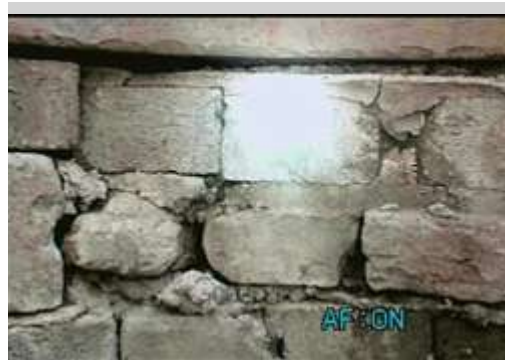
Defect 1

Condition: ☐ Sound ☒ **Cracked** ☐ Root Intrusion ☒ **Loose Brick** ☒ **Deteriorated**

Infiltration: ☐ None ☐ Joint ☐ Cracks ☒ **Mortar** ☐ Roots ☐ Wall

chimney cond loose bricks, chimney cond deteriorated, chimney cracked

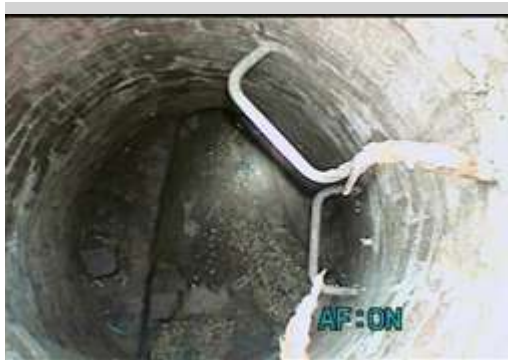
DEFECT

Count: **3** Missing: **1** ☒ **Corroded**

CORRODED STEPS
